## GFRC Cladding Systems, LLC

## Façade Re-cladding with GFRC

### What is GFRC?

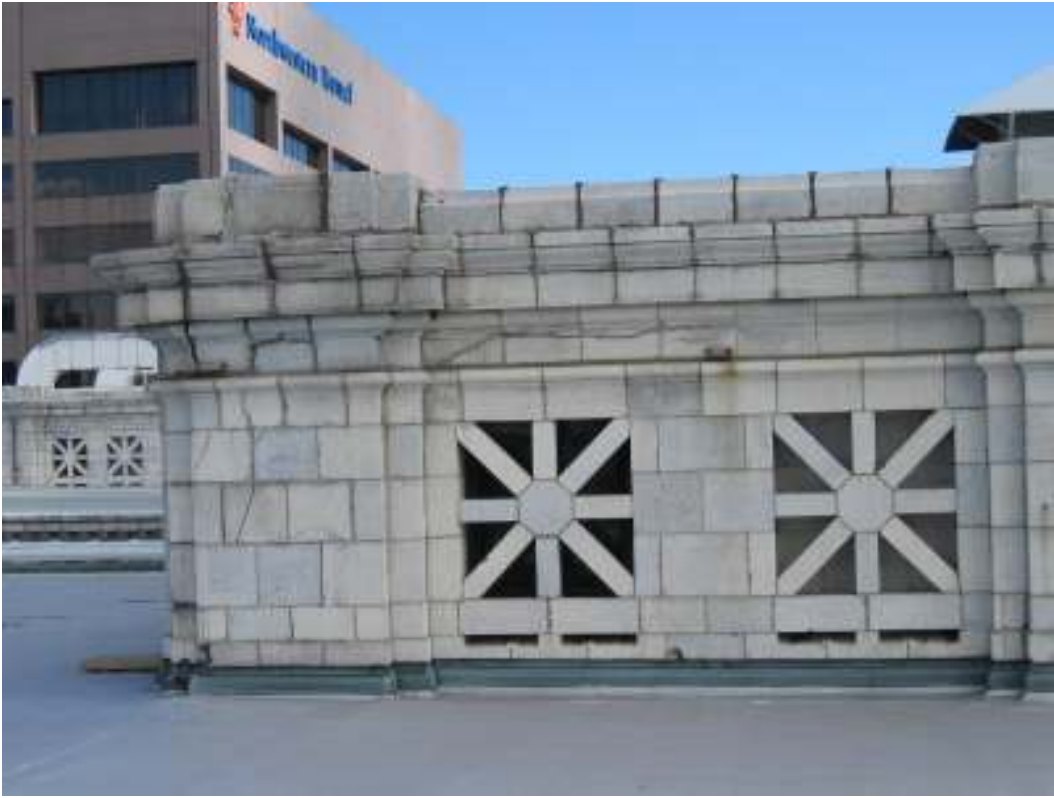
***Fig. 1a: Terra cotta Penthouse (Before demolition)***

In May of 2007, GFRC Cladding Systems completed the refurbishment of a mechanical penthouse located on top of a 90+ year old corporate headquarters building in Milwaukee, WI. The cracked and weathered terra cotta tiles shown in **Fig. 1a** below were first removed, and then replaced with a new panelized GFRC system (**Fig. 1b**).

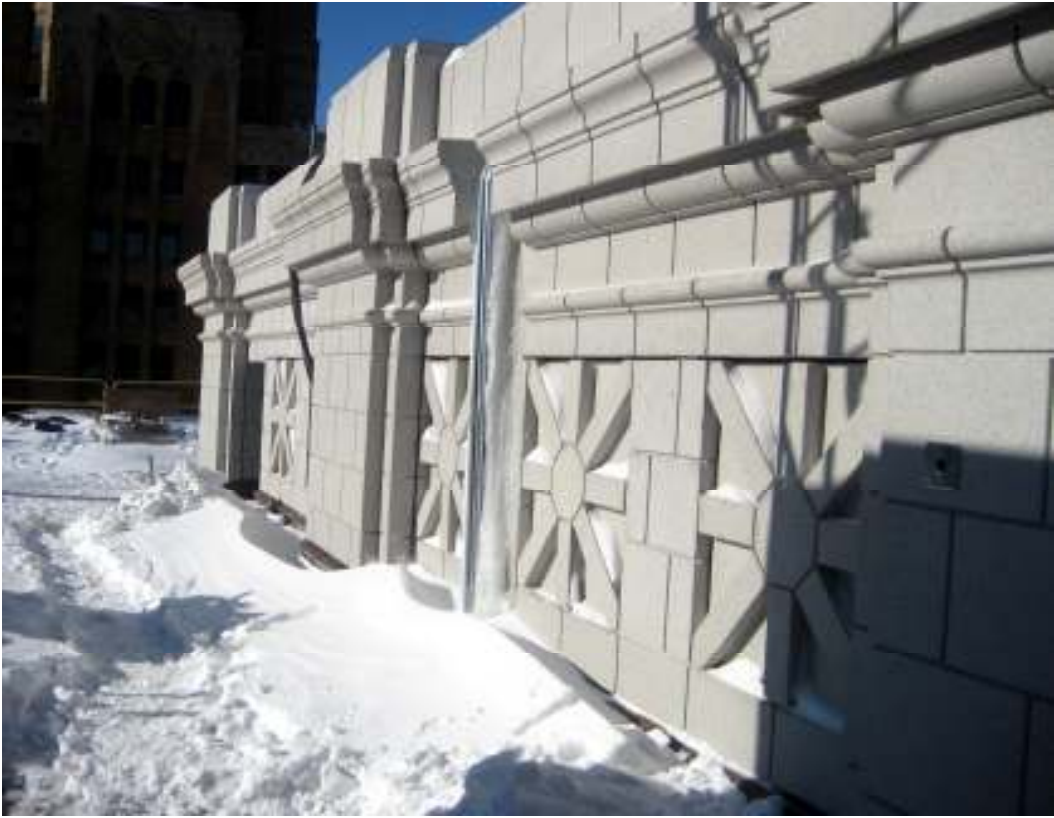
***Fig. 1b: GFRC Penthouse (After recladding)***

Note the use of rustication in the GFRC panels to reproduce the look of individual terra cotta tiles. Following this penthouse re-clad, GFRC Cladding Systems was asked to replace all the remaining terra cotta penthouses and interior atrium, as well as a large water-damaged granite cornice around the top floor. During this phase, which was completed in October, 2009, over 1,900 panels totaling 54,000 square feet were engineered, fabricated and erected.

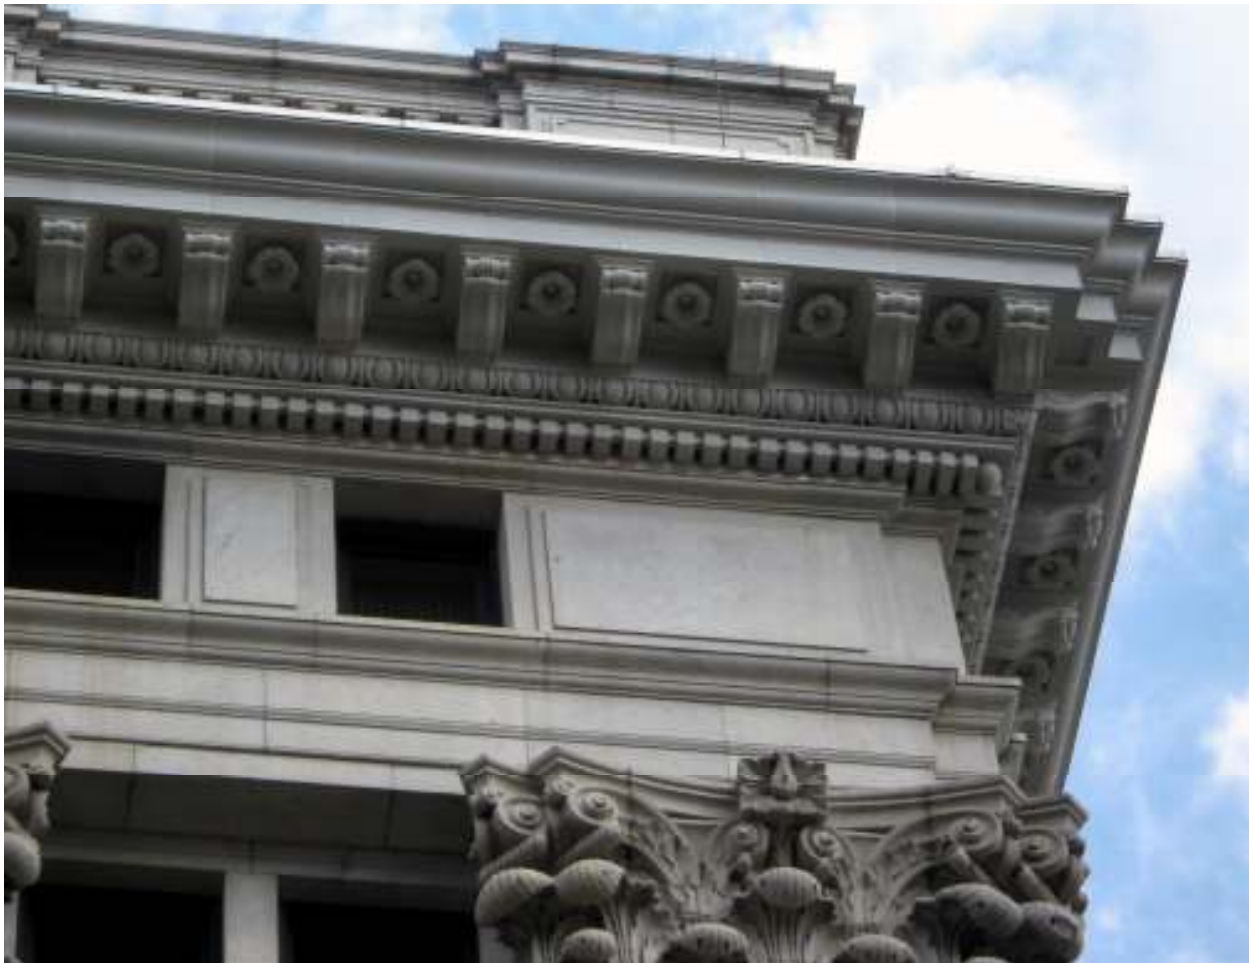
**Fig. 2: GFRC Cornice**

The highly elaborate GFRC cornice shown in Fig. 2 consists of a projecting ogee with a deep soffit return with alternating cast rosettes and brackets, and a lower entablature with a classical "egg & dart" pattern and dentils. Many of the GFRC shapes on this cornice were fabricated from rubber molds cast directly from the existing granite and terracotta components. Panels were erected from the outside of the building only, with minimal interference to the offices or ongoing building functions during the reconstruction.

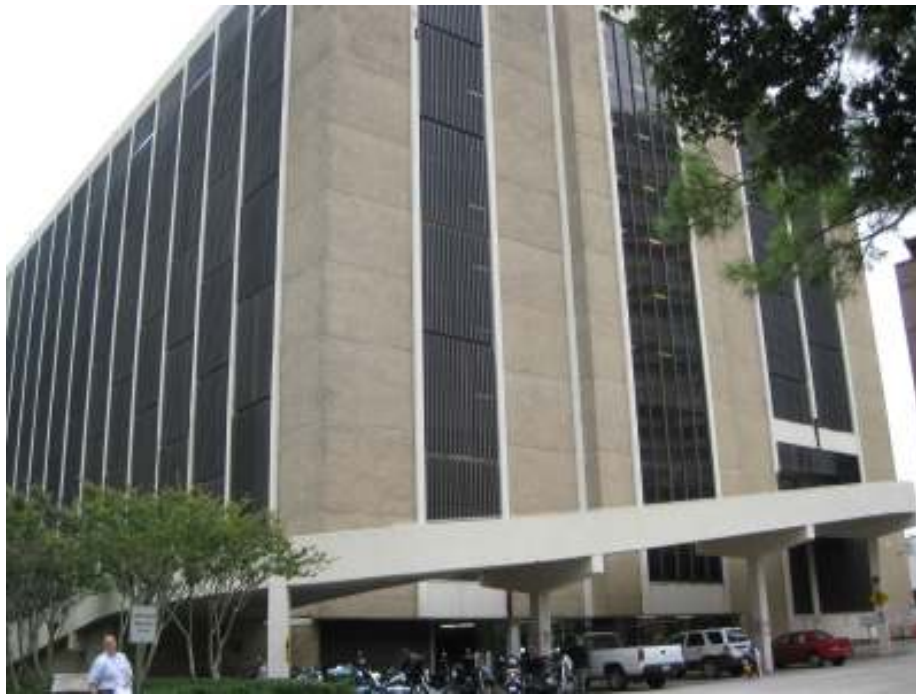
**Fig. 3:** *Marblecrete facade before demolition*

**Case Study:** On an 11 story parking garage in Houston, Texas, the existing Marblecrete exterior (**Fig. 3a**) had corroded to the point that it was no longer structurally viable, and had to be replaced. Because of the high relative humidity and rainfall typical of the Gulf Coast, the owner wanted a replacement cladding without steel framing or other potentially corrodible elements. Panels had to be designed to resist high wind loads, yet be light-weight to minimize superimposed loads on the existing structure. Connection spans of nearly 15 feet made the design and engineering of the GFRC panels particularly challenging.

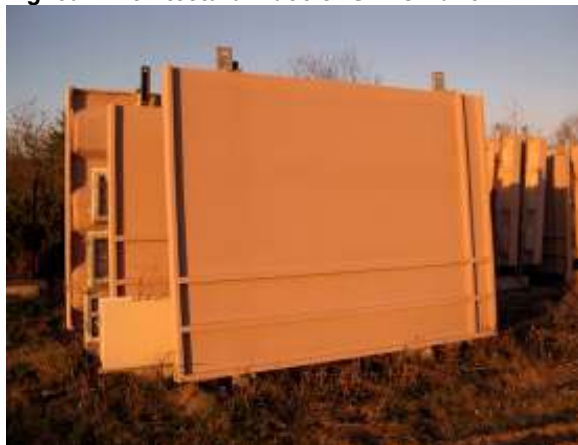
**Fig. 3a:** *Architectural Face of GFRC Panel*

**The Solution:** In lieu of an integral steel panel frame, hollow GFRC “ribs” 6” to 9” deep were cast on the back side of the panel. These horizontal ribs are designed to resist wind loads, and transfer them to the two vertical “beams”. Threaded inserts embedded in the beams provide connection points for welding or bolting the panels to the parking garage structure.

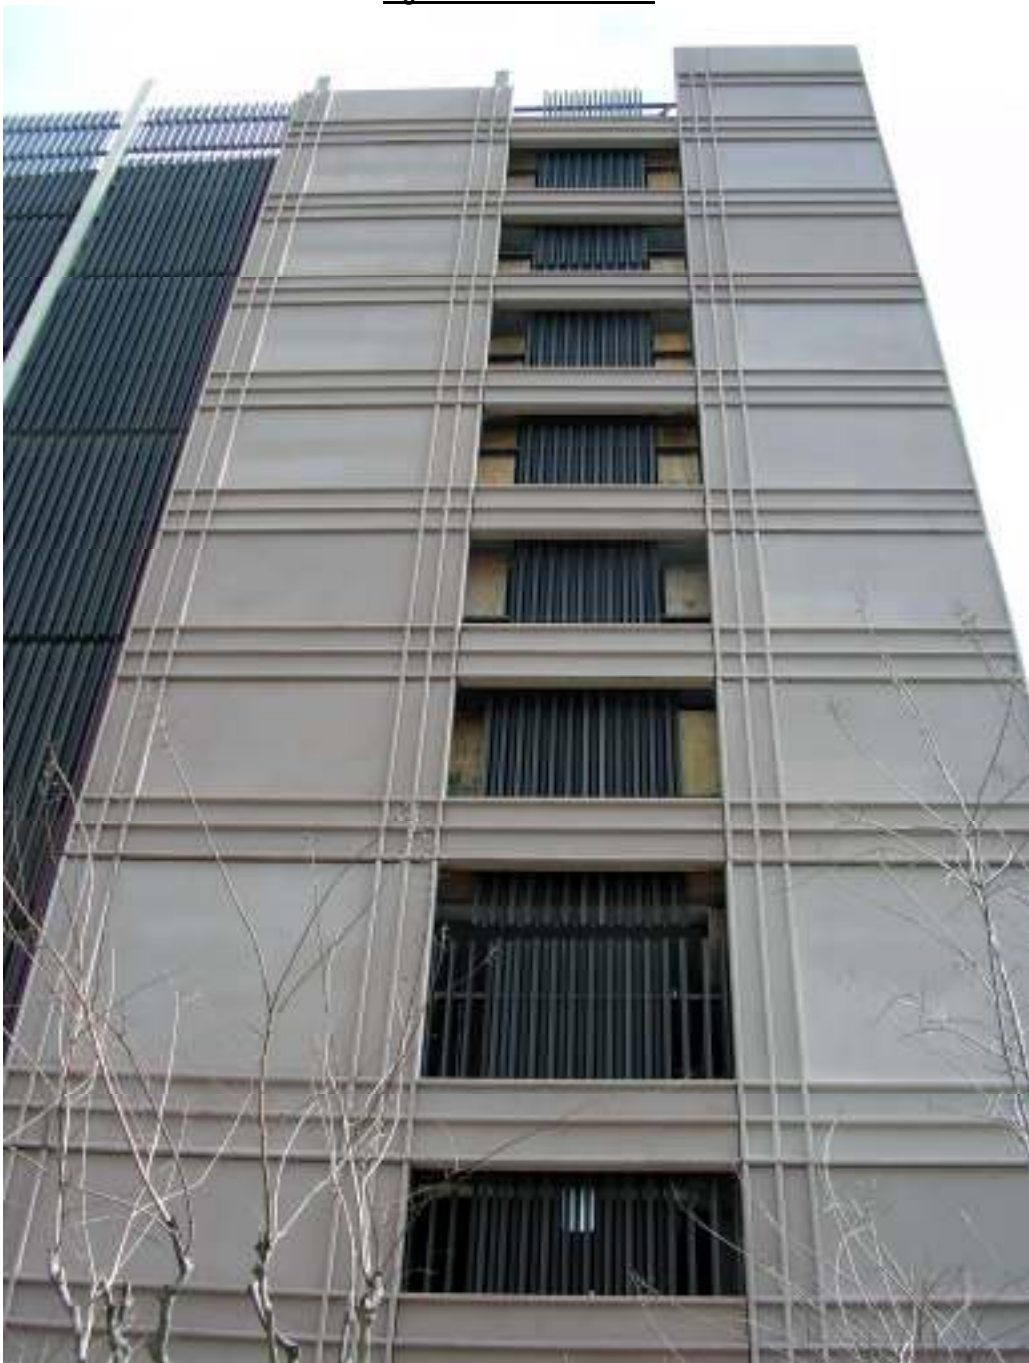
**Fig. 4: New GFRC Facade**

Over 500 total panels, totaling over 40,000 SF, were fabricated for this application. Panels were installed at night to enable the parking garage to be used continuously during construction. **Fig. 4** shows the new GFRC facade:

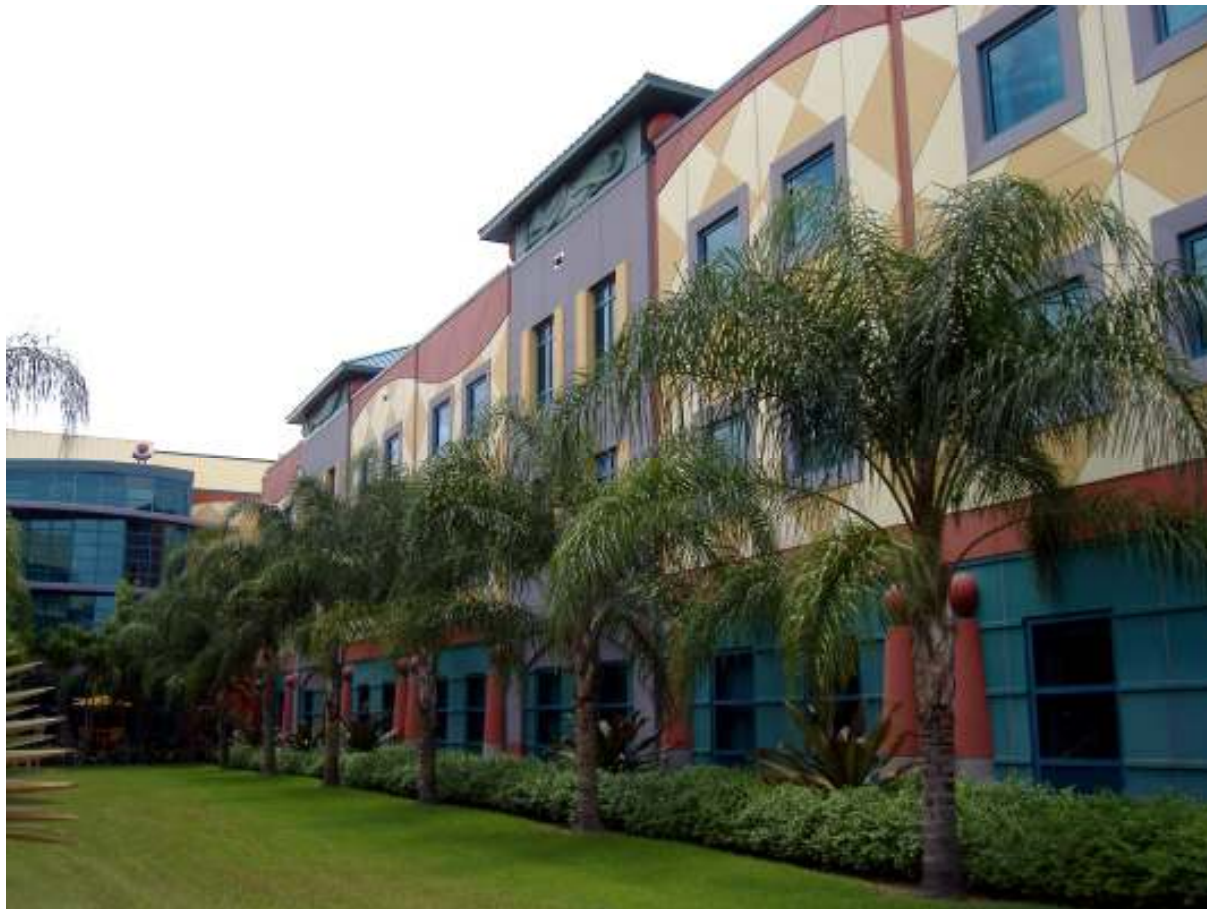
***Fig. 5: Miami Childrens Hospital Reclad***

To minimize the impact on patient care during construction, all erection work had to be carried out from outside the building. First, holes were punched into the existing EIFS cladding and steel outriggers were connected back to the existing concrete structure. The GFRC panels were then hung over the old facade and supported on the new cantilevered steel structure. Panels had to be light enough to install directly over the existing EIFS, yet strong enough to withstand Hurricane force conditions without exposing the building interior to wind or water.

Nearly 90,000 square feet of highly profiled and articulated GFRC panels were fabricated, stained at our factory in seven different colors, and shipped to the job site for installation.
